NASA/TM-2014-218538
NESC-RP-14-00957

A Comprehensive Analysis of the X-15 Flight 3-65 Accident

October 2014

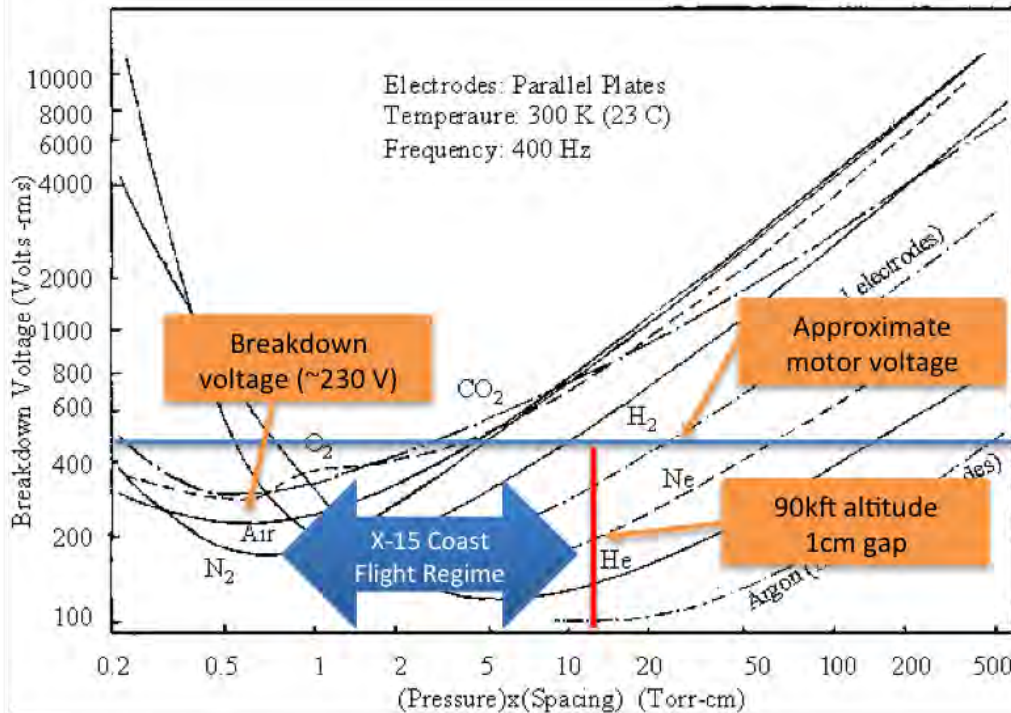
Figure 8.1-1. Paschen Curve for 400 Hz Potential at 300 degrees Kelvin [ref. 32]

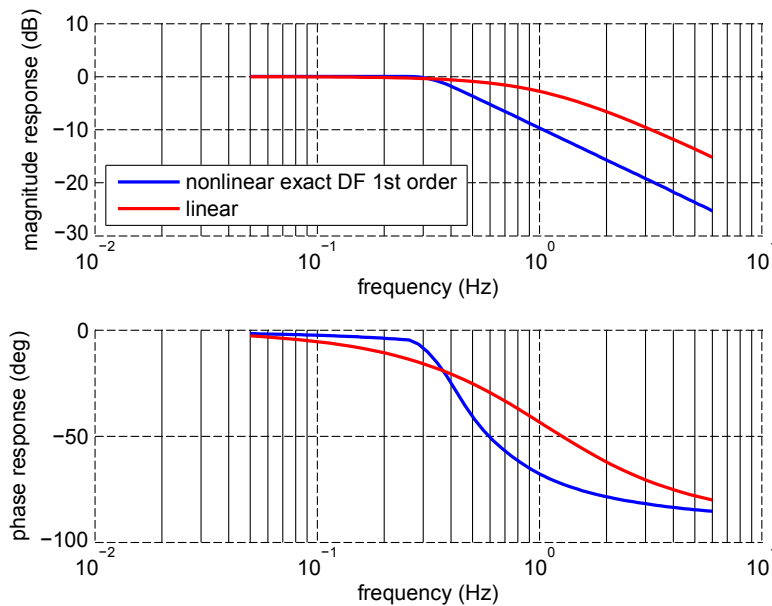
damping was particularly low, as it did during Flight 3-65, then the rigid-body oscillation was divergent, even with fixed adaptive gains.

Figure 8.5-2. X-15 Power Actuator under Rate Saturation, 15-degree Amplitude

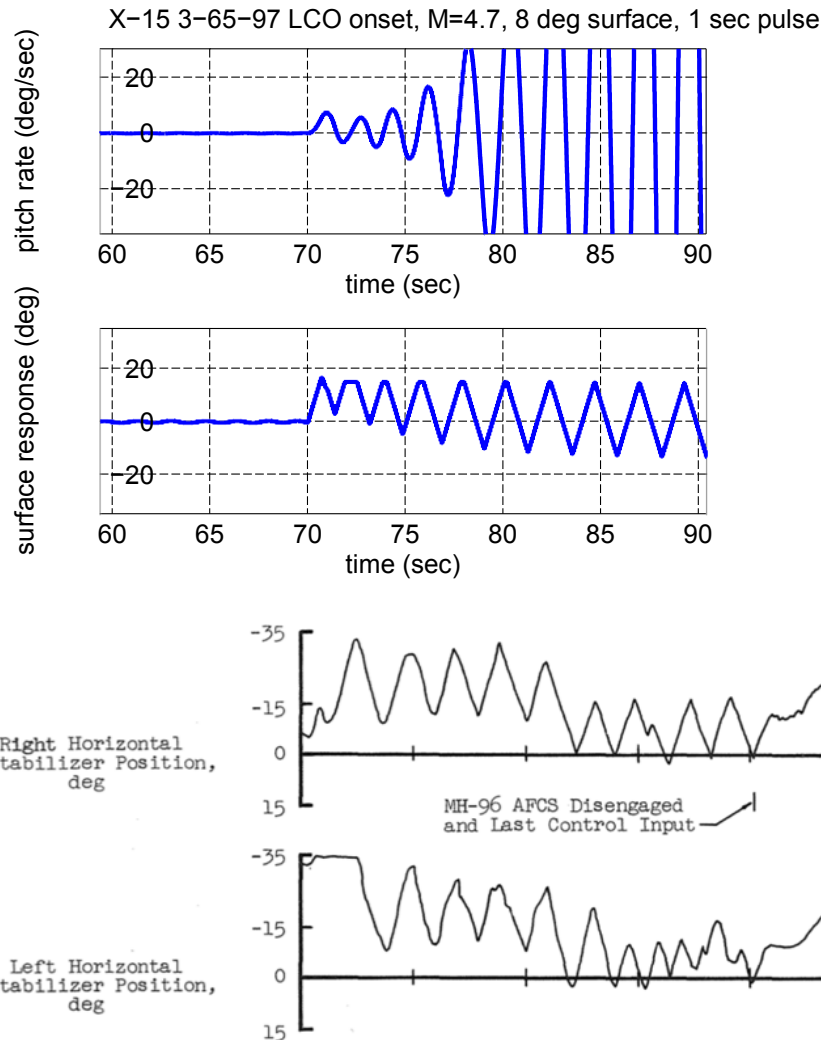
Figure 8.5-3. X-15 3-65 MH-96 Servo Actuator LCO (simulated) versus Flight Data

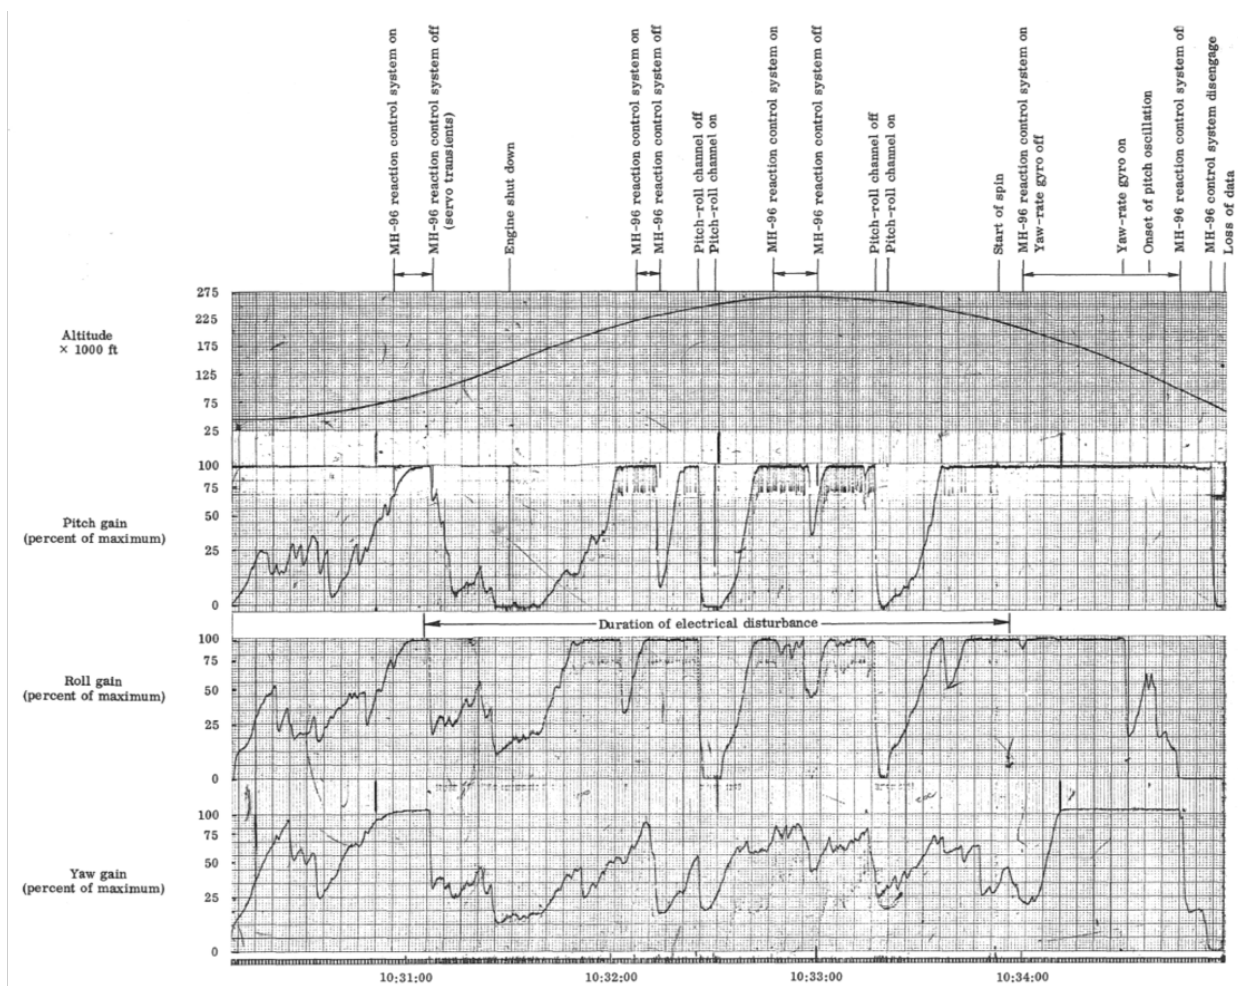
However, 14 seconds later, at 10:33:39 PST (MET + 211 seconds) and about 240,000 feet, the pilot reported that the aircraft control seemed “squirrely.” Twenty-two seconds later at 10:34:01 PST (MET + 233 seconds), the pilot said, “I’m in a spin.” Ground control did not acknowledge either of these transmissions. The pilot repeated, “I’m in a spin,” at 10:34:16 PST (MET + 248 seconds). At 10:34:17 PST (MET + 249 seconds), the flight controller said, “Say again.” At 10:34:17 PST (MET + 249 seconds), the aircraft was in descent at 184,000 feet with a velocity of 5,100 fps. The aircraft would begin to break apart 37 seconds later.

Figure 9.1-2. AFCS Gain Variation during Flight 3-65

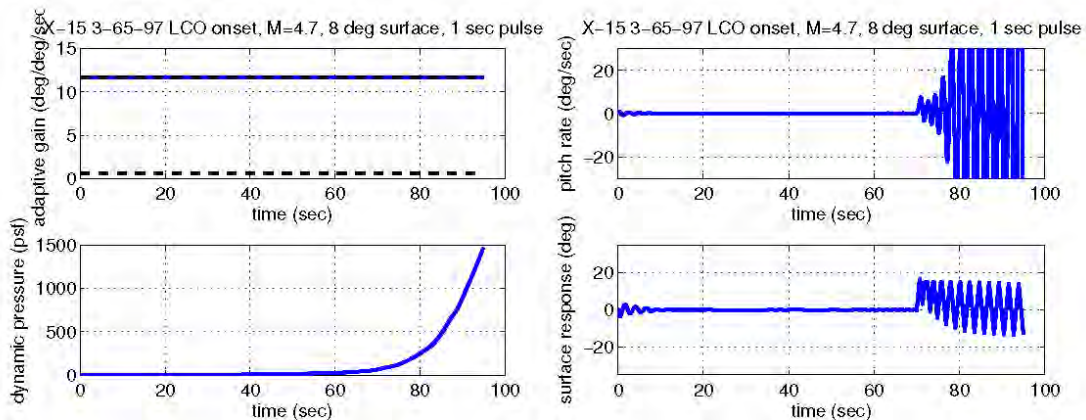
The adverse LCO appears in the anomalous entry due to saturation of the control surface actuators such that the short-period pitch mode of the aircraft is simultaneously excited during the period when the gain adaptation would otherwise be rapidly reducing system gain to compensate for the rapid increase in dynamic pressure (Figure A.15).

Figure A.15: MH-96 3-65 entry, pilot input

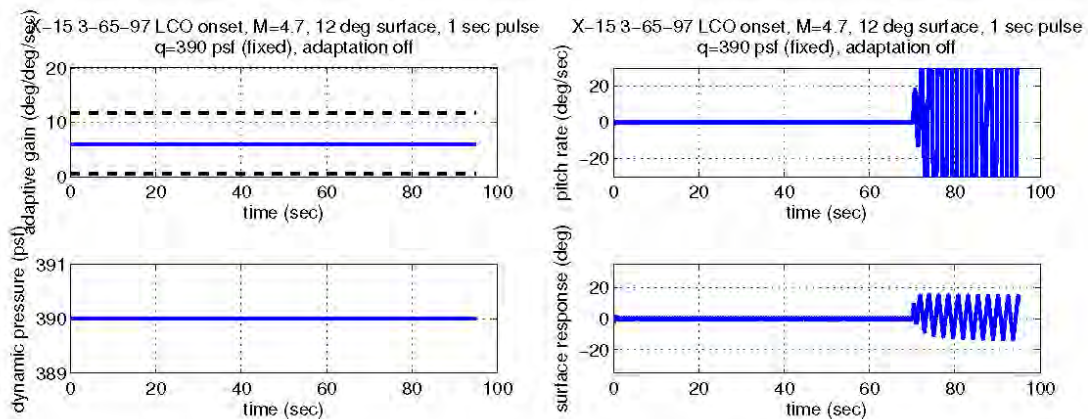
The same divergent LCO can be induced in the system even in a fixed gain condition with fixed dynamic pressure, if the pilot input magnitude is large enough to induce rate limiting in the actuator (Figure A.16). This occurs with moderate gain levels exceeding those of the fixed-gain SAS but much below the MH-96 maximum gain. This implies that a more serious mechanism involving the fundamental stability of the SAS inner loop is responsible for the limit cycle behavior, since in the fixed-gain case the behavior persists.

Figure A.16: Fixed dynamic pressure, large pilot input, fixed gain

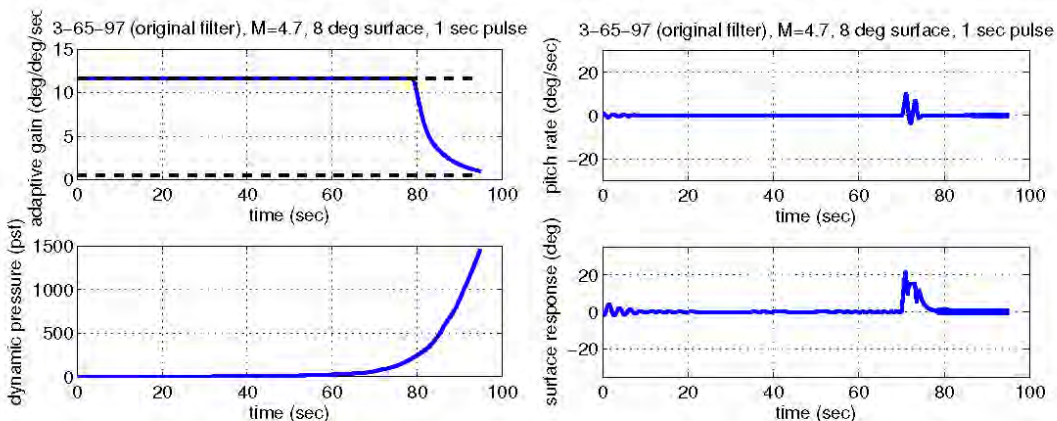
It is illustrative to consider that the introduction of lag due to the implementation of the structural notch filter may be related to the apparent rate-limit divergent limit cycle oscillation. Under the time-varying 3-65 entry conditions, the system is simulated with an identical pilot input but with the original loop filter design (Eq. A.7). Although rate limiting is induced for a short time, the actuator does not couple with the short-period mode and thus no divergent oscillation is induced (Figure A.17).

Figure A.17: 3-65 entry, large pilot input, original filter

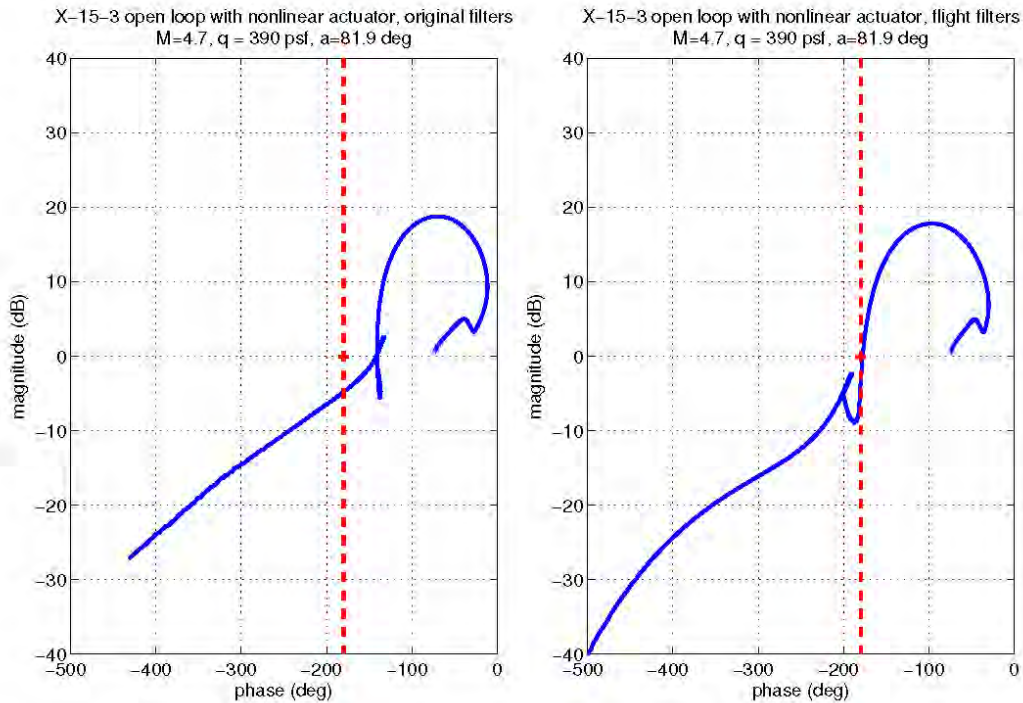
Based upon the time-domain analysis, it was observed that the large-amplitude LCO tended to be precipitated by large inputs causing actuator rate saturation coupled with an excitation of the short-period pitch mode. In order to determine the possible transition amplitude for the adverse LCO, the amplitude-frequency parameter space was searched for a DF such that the short-period mode would approach critical stability when at the 3-65 entry conditions (maximum forward gain, 390 psf). The transition amplitude for this condition consists of a large servo command of approximately 80 degrees peak equivalent, or a command-to-authority factor of about 6:1. Large servo commands exceeding the servocylinder limit of 1 inch (15 degrees equivalent) will cause saturation in the servo, the power actuator, or both. The effects of saturation on the actuator frequency response are shown in Figure A.22. Near the short-period frequency, the effective phase lag is increased by approximately 25 degrees.

Figure A.23: X-15 servoactuator large-amplitude LCO prediction

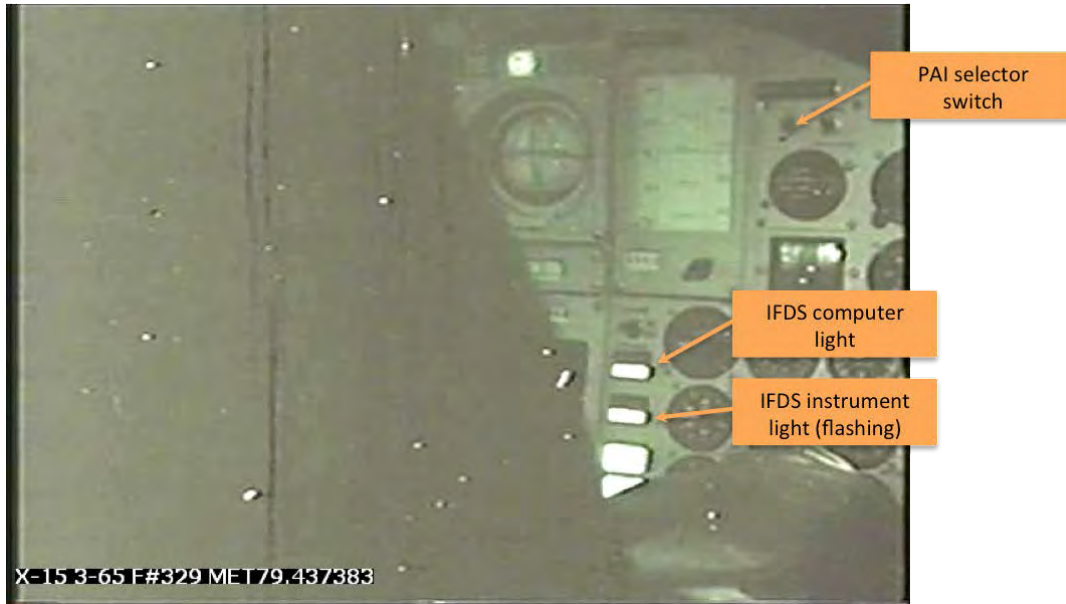
Figure B-10. Cockpit Film – Begin IFDS Malfunction (MET = 79 seconds, 10:31:27 PST)

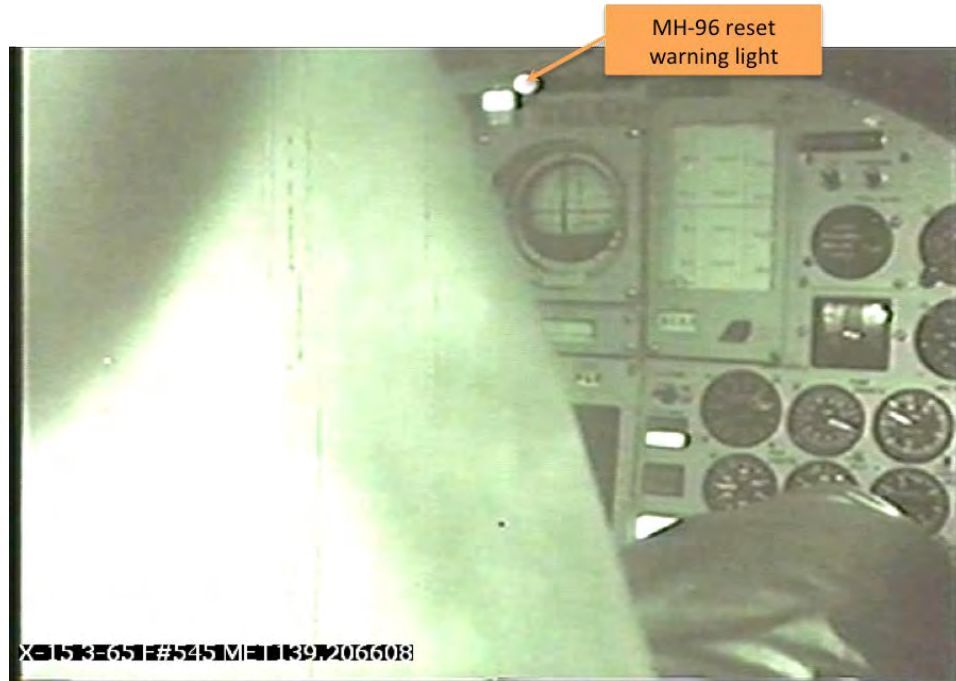
Figure B-14. Cockpit Film – One of At Least Two MH-96 Disengages (MET = 139 seconds, 10:32:27 PST)

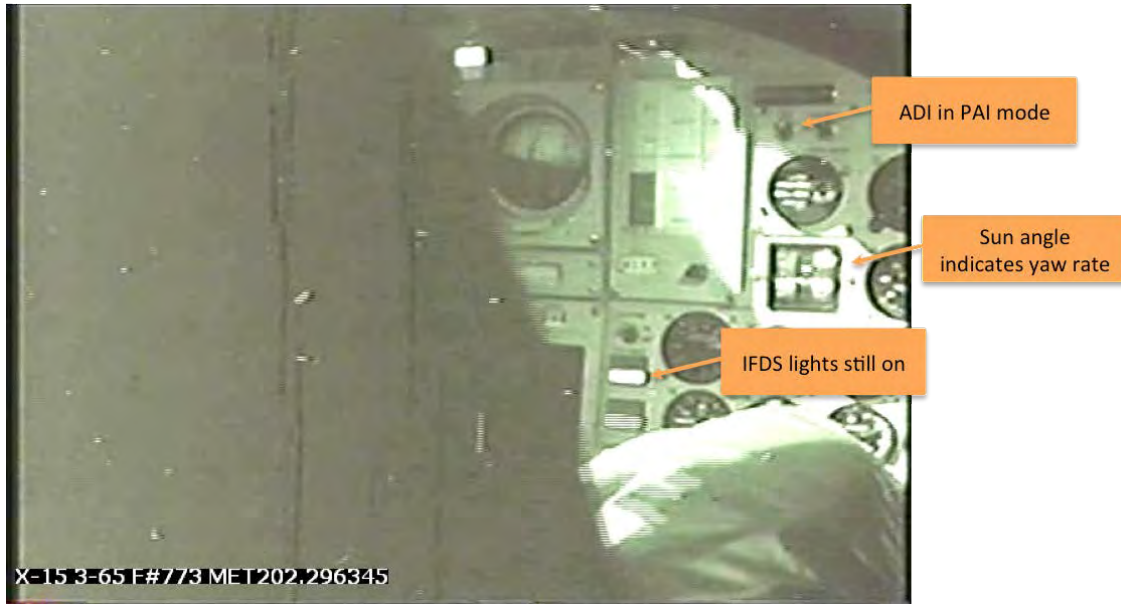
Figure B-16. Cockpit Film – Spin Entry (MET = 202 seconds, 10:33:30 PST)
