NASA/TM—2014–218414

The Human Factors of an Early Space Accident: Flight 3-65 of the X-15

Immanuel Barshi
NASA Ames Research Center

Irving C. Statler
NASA Ames Research Center

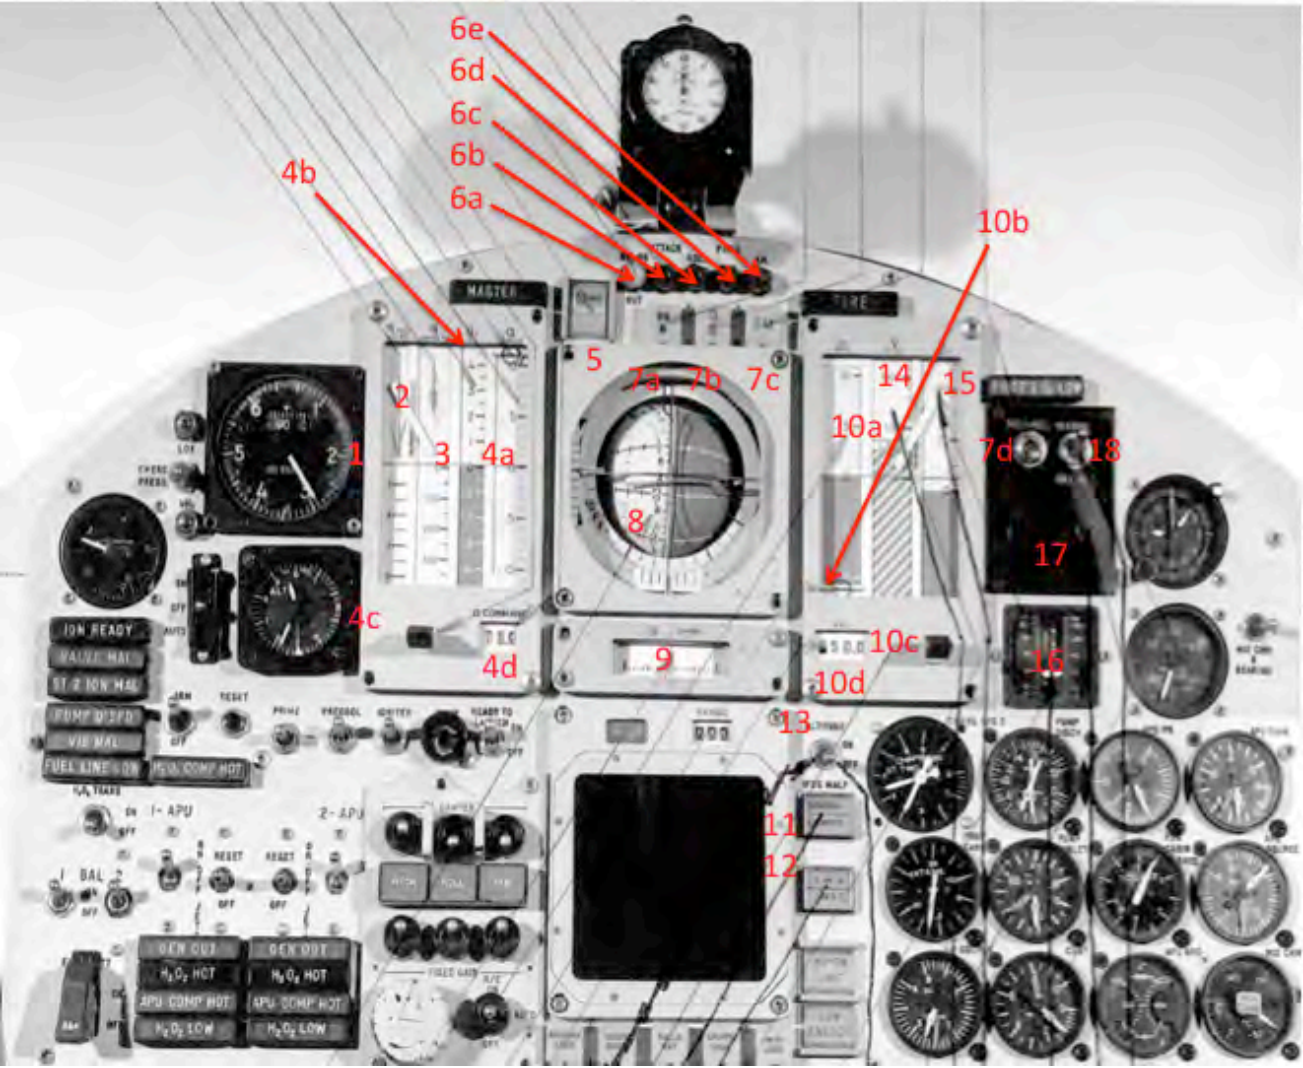
Figure 3a. Pilot's display panel in the X-15-3 (Figure 3a in AIB report).

- When the dynamic pressure became less than about 50 psf, the normal procedure for the pilot was to push a switch on the display panel (switch 5 in Figure 3a, the bottom half of which flashes amber to alert the pilot) that changed the source of data for the angle-of-attack and angle-of-sideslip from the aerodynamic source of the 'ball nose' to the IFDS computer. On Flight 3-65, the dynamic pressure fell below 50 psf at about 155,000 ft. at 10:31:35, by which time the IFDS computer had already failed and the computer and instrument malfunction light had come on. Although he did not make a verbal report, the post-accident examination of the cockpit film shows that Major

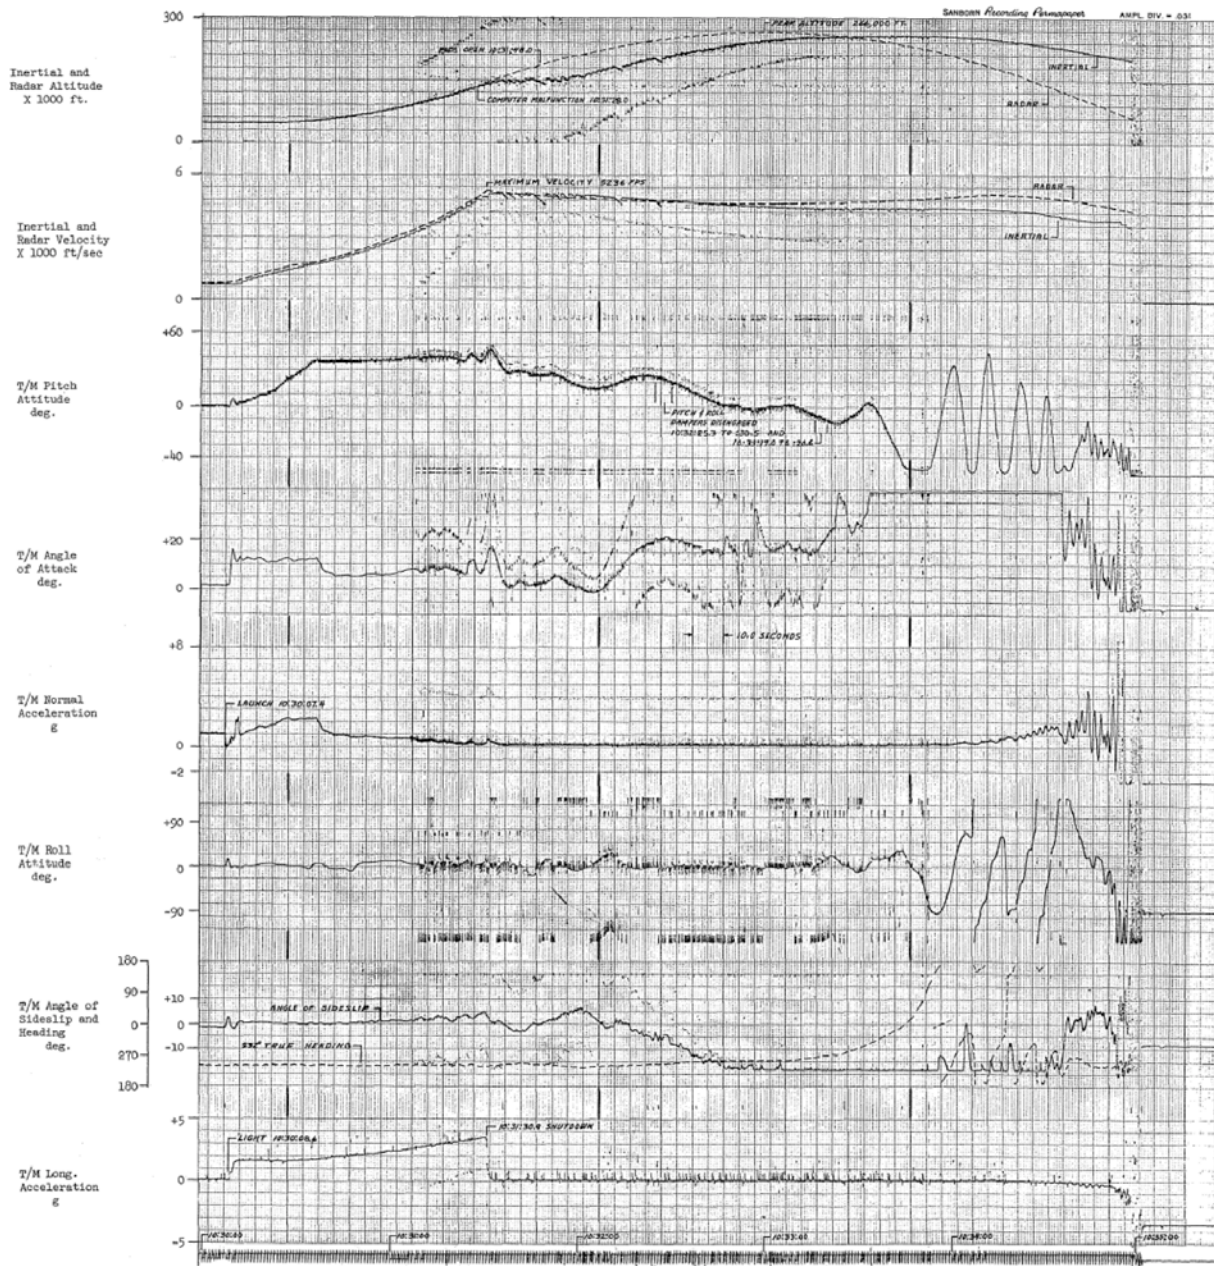
Figure 4. Time history of Flight 3-65 (Figure 6 in AIB report).

- At 10:31:07 (only 1 minute after launch), all of the telemetered data suddenly became erratic and remained so for several minutes (see Figure 4). For example, ground control was aware of continuing anomalous servo transients from these telemetered data. The AIB report [1] states: *“The transient motion of the three servos was not due to pilot inputs or aircraft motion, but was apparently electrical and was of sufficient frequency content and amplitude to drive all three control gains well below their normal values for the particular flight conditions at which it occurred. The gain reduction in all three channels was great enough to cause the primary reaction controls to automatically disengage”* (pg. 38).

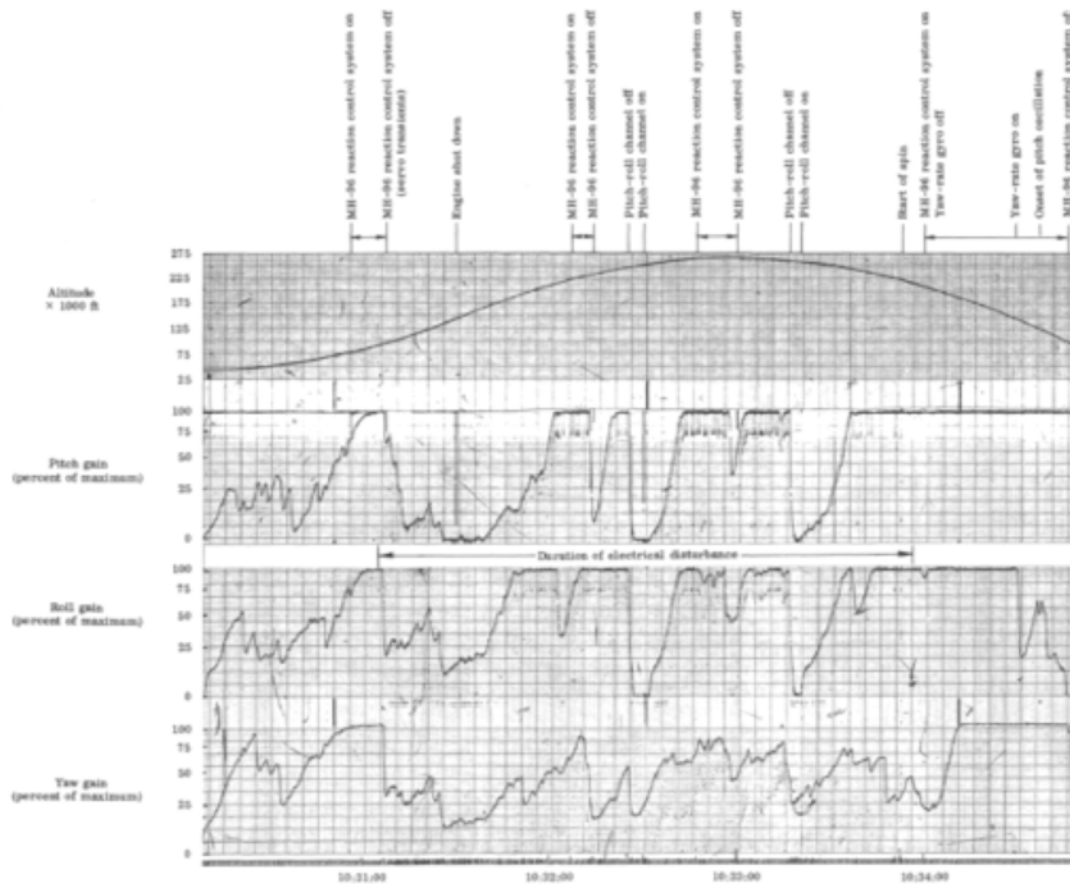
Figure 5. Time history of MH-96 control system gains during Flight 3-65 (Figure 17 in AIB report).

As seen in Figures 5 and 7, at 10:31:00 all three gains on inputs to the aerodynamic controls were at their maximums so that the MH-96 had automatically opened the gateway for inputs to the RCS and the pilot's right-hand side stick was operational at that point. Seven seconds later, the total gain of the three aerodynamic controls had decreased below 75% of its maximum so that access to the RCS was closed by the MH-96. From then on, the pilot's right-side-stick control of the RCS was intermittent because of the erratic fluctuations in the automated gain controls due to the continuing electrical disturbance. The pilot was unable to detect this intermittency of control for nearly 3 minutes, which is not surprising given the on-off nature of the RCS and the intermittent nature of the failure. Cockpit indicators showed that the engagement of the pitch and roll dampers were also intermittent during the electrical disturbance.

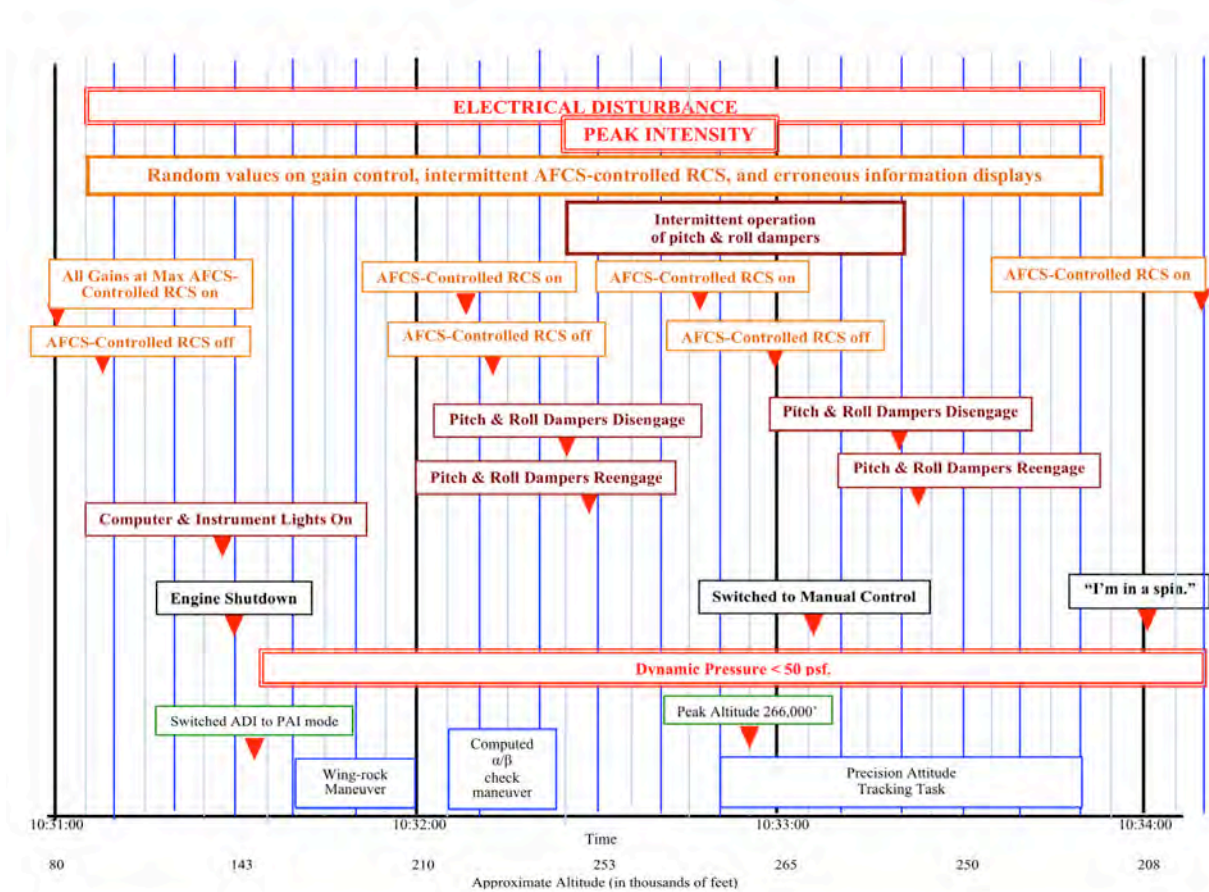
Figure 6. Time line of critical events leading up to entry into spin.

Figure 6² diagrams the time line of what is considered to have been the key events during the 3 minutes following the initial arcing. Appendix A presents a detailed sequence of the events from the moment of launch that includes an annotated transcript of the radio communications between ground control and Major Adams. Note how much was going on during that short time!

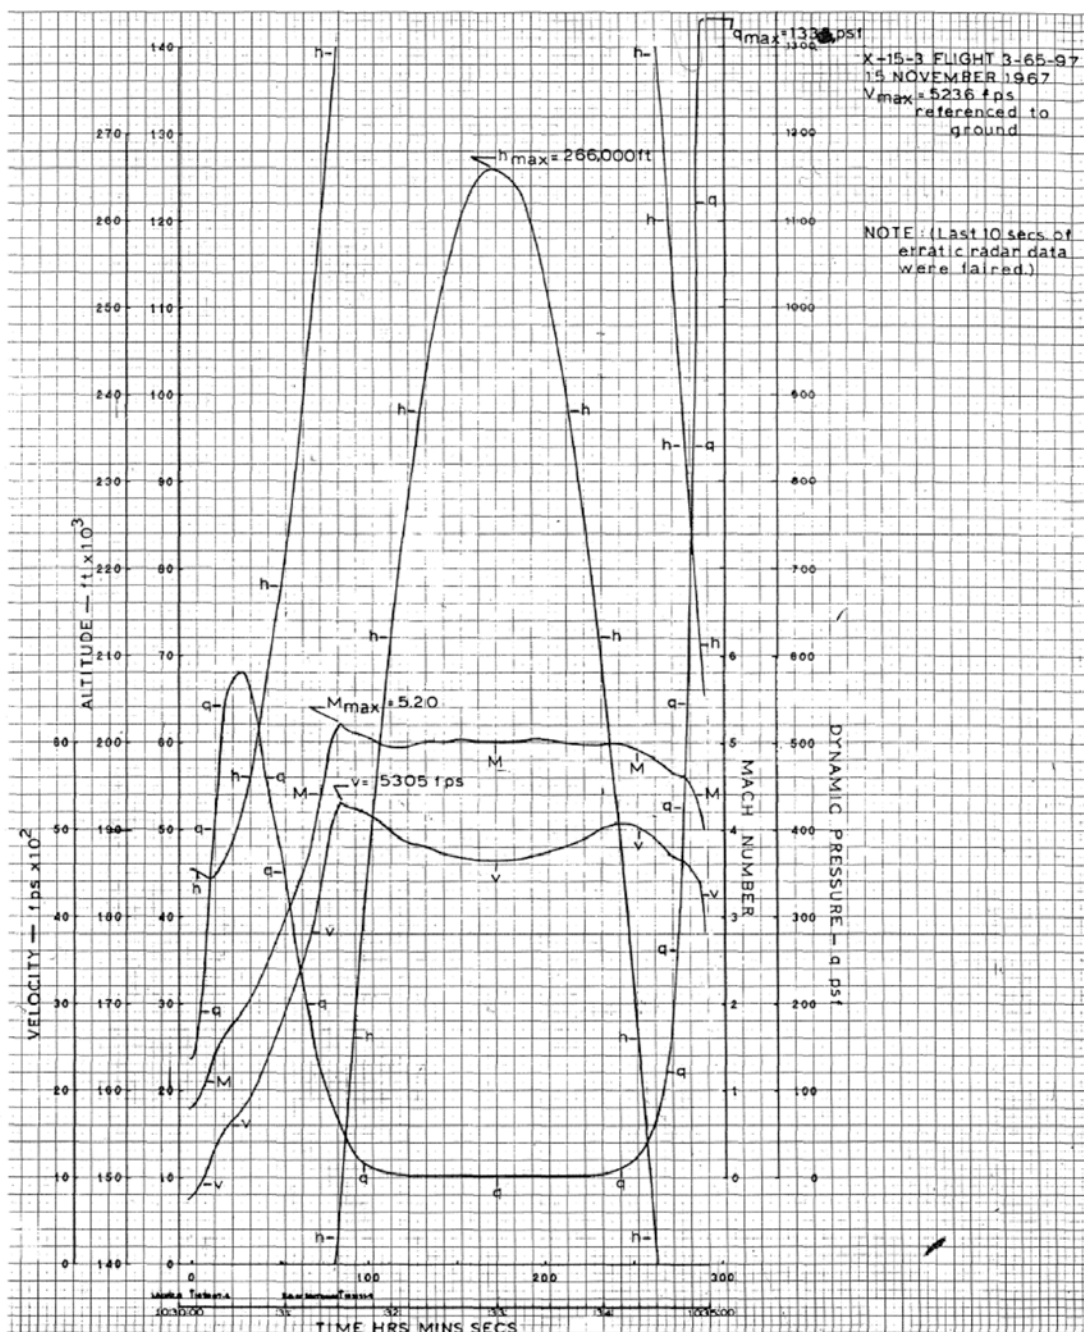
Figure 8. Variation of altitude, Mach number, and dynamic pressure during Flight 3-65 (Figure 8 in AIB report).

At 10:34:17 the aircraft was in descent at 184,000 ft. with a velocity of 3,022 knots (5,100 fps; see Figure 8). It was pitched up at about 40°, had a roll rate of about 20° per second, and at more than 90° off of its intended heading (see Figure 4). The dynamic pressure was still less than 20 psf, which meant that the aerodynamic controls and the ball-nose indicator were ineffective.

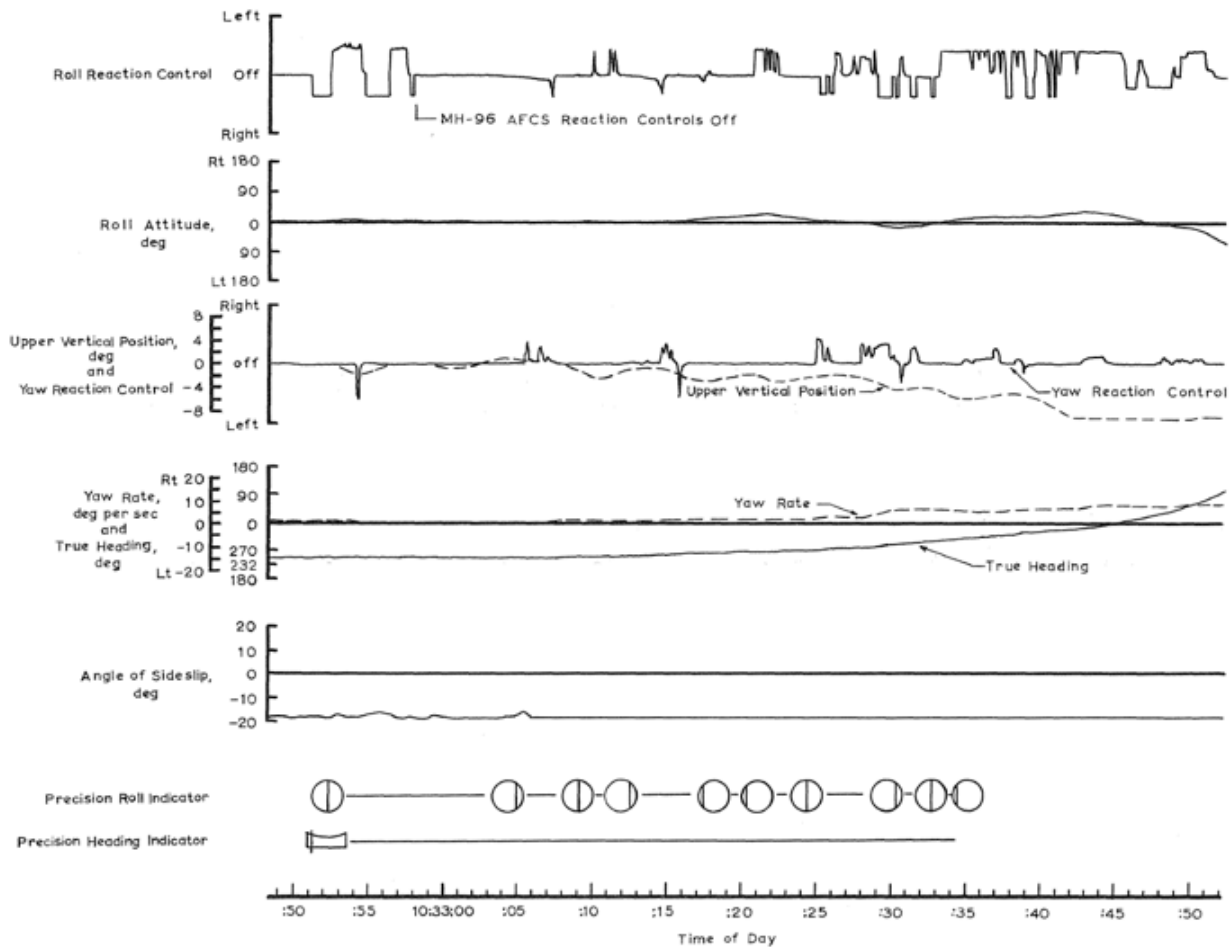
Figure 9. Time history of precision attitude tracking task at peak altitude (Figure 13 in AIB report).

- The evidence indicates that Major Adams did not disengage the MH-96 AFCS as he was supposed to when he switched to the left side stick control. This was a very important failure because the subsequent instability would have been avoided if Major Adams had remembered to disengage the AFCS when he switched to direct manual control and recovery from the dive might have been possible.⁷
