NASA/TM-2014-218538
NESC-RP-14-00957

A Comprehensive Analysis of the X-15 Flight 3-65 Accident

October 2014

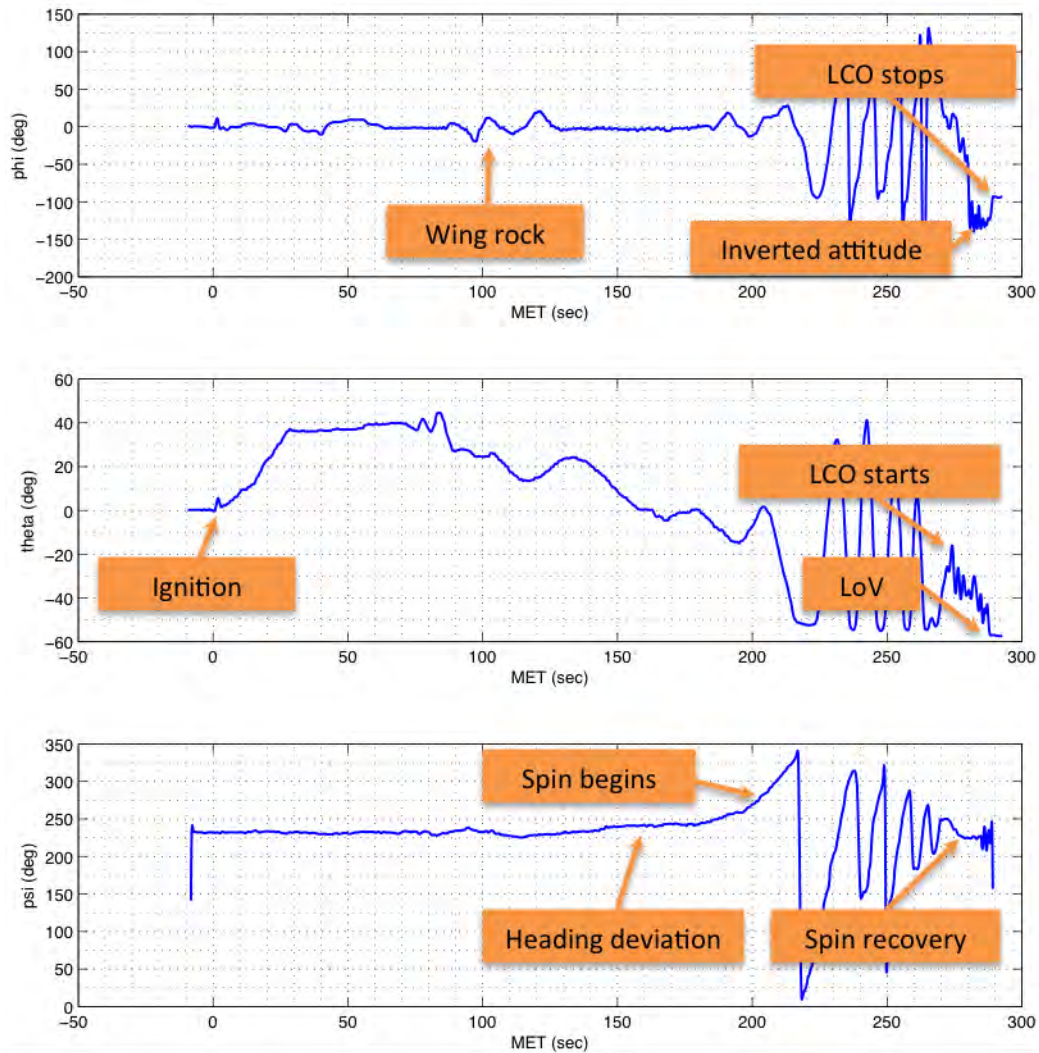
Figure 7.3-1. X-15 3-65 Reconstructed Flight Data (attitude angles⁹)

Reconstructed flight data depicting key events with respect to the aircraft attitude angles are shown in Figure 7.3.1. These data were derived from filtered measurements of the IMU resolver angles recovered from the original stripchart recordings. The correctness of the IMU angle data was verified by the post-accident investigation team via correlation of the estimated attitude with a known solar angle in recovered film footage from onboard cameras [ref. 3]. The remaining trajectory data appear in Appendix B.

In Figure 7.3-1, MET is referenced to ignition, which occurred at 10:30:08 PST. The onset of spin entry at approximately 10:33:30 PST (MET + 202 seconds) was based on the rapid increase in yaw rate and the observation of the first traversal of the sun across the instrument panel as seen from the cockpit camera. Note that the aircraft was tumbling after approximately MET + 215 seconds, and the attitude resolver angles wrap through 360 degrees, but are masked by noise filtering.

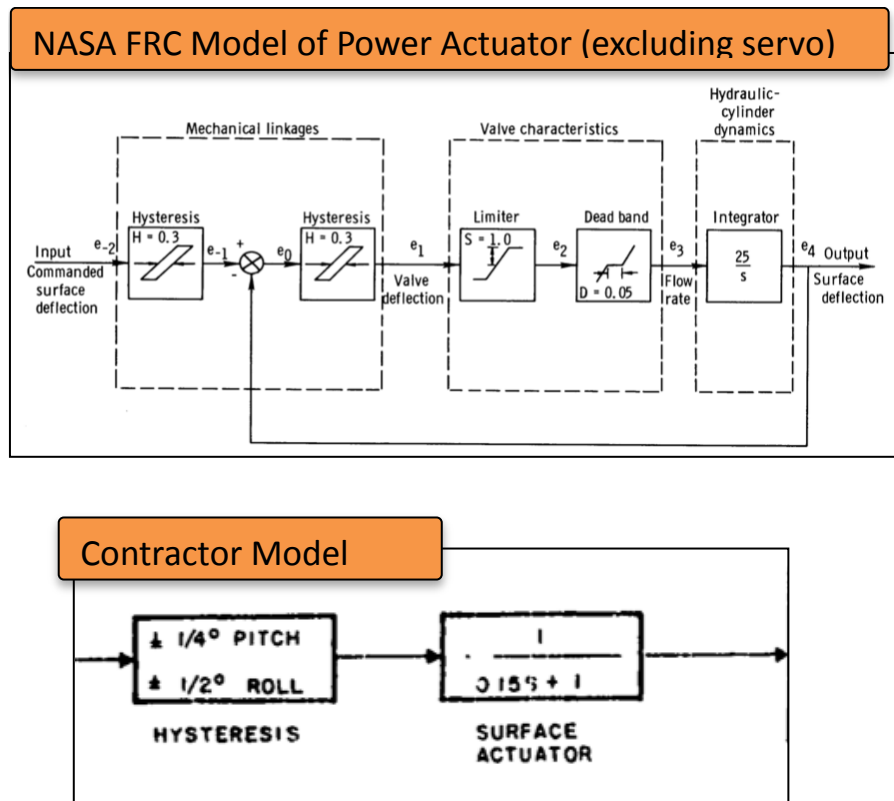
Figure 8.5-1. Surface Actuator Models Used in Design [refs. 34 and 35]

However, while NASA FRC had used a nonlinear model of the servo and power actuator with more extensive HWIL simulation to verify the filter design, the contractor apparently did not have access to the same type of model data and used a simple first-order lag model with hysteresis only (Figure 8.5-1). As such, a latent design sensitivity was introduced into the inner loop of the MH-96 SAS that would allow the SAS rate loop to become unstable in the presence of actuator rate saturation.

The transition from the desirable small-amplitude LCO to the large-amplitude destructive LCO was an artifact of the rate-limited power actuator with its semi-integrating servo loop. A known effect of power actuator rate limits is the introduction of an amplitude-dependent equivalent phase lag in the inner loop, which plays an important role in the sensitivity to pilot-induced oscillations (PIO). As can be seen in Figure 8.5-2, the presence of rate limits severely degrades the equivalent nonlinear frequency response of the X-15 actuator. The severe landing PIO encountered on X-15 Flight 1-1-5 was an effect of the same rate-limited actuators, albeit in a different failure mode [ref. 36].

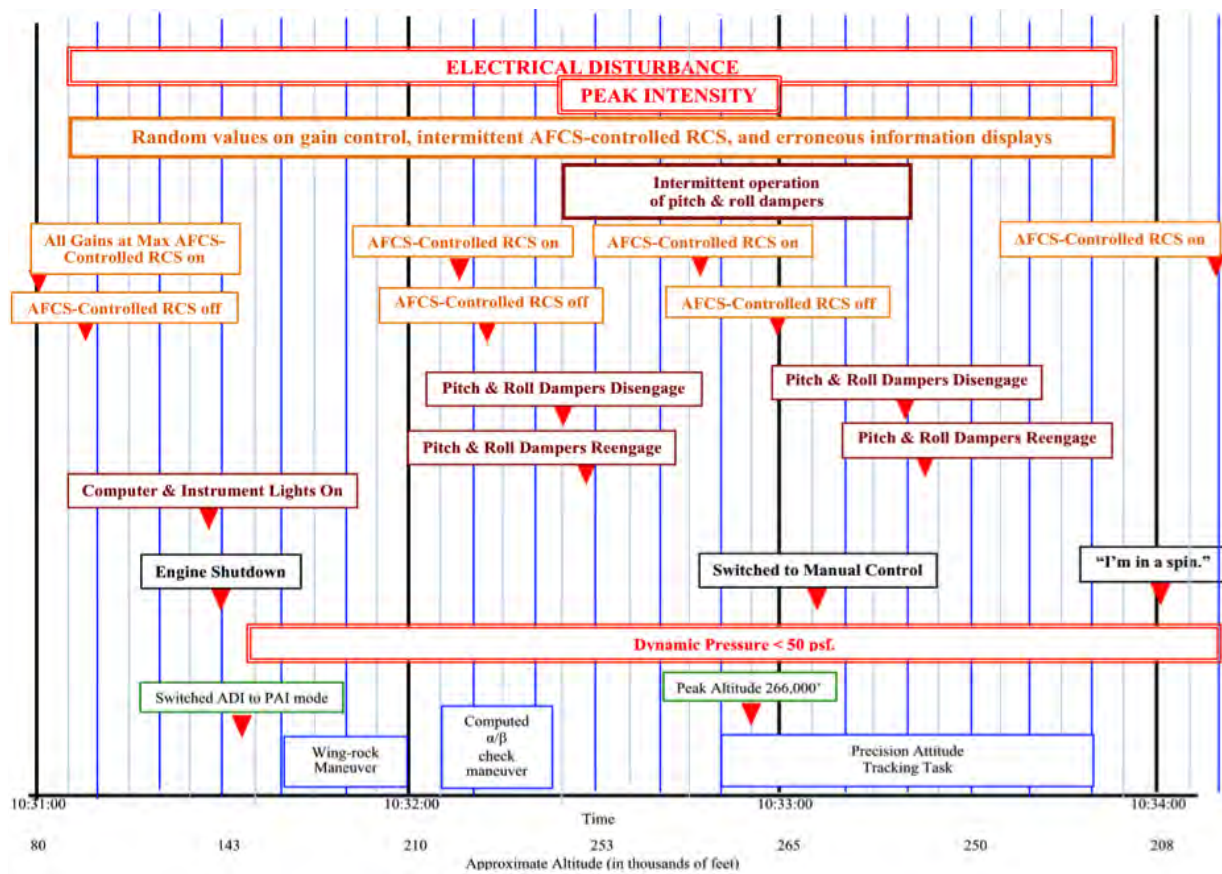
Figure 9.1-1. 3-65 Event Timeline

Figure 9.1-1 illustrates the timeline of the major events leading to the loss of the pilot and the aircraft, and diagrams the sequence of key events during the 3 minutes following the initial traverse probe electrical disturbance. Note that the timeline in Figure 9.1-1 ends at about 10:34:17 PST (MET + 249 seconds), or about 37 seconds before breakup. The time history of the MH-96 AFCS gains is shown in Figure 9.1-2.

At 10:32:27 PST (MET + 138 seconds), the pilot reported that the pitch and roll dampers had tripped out.

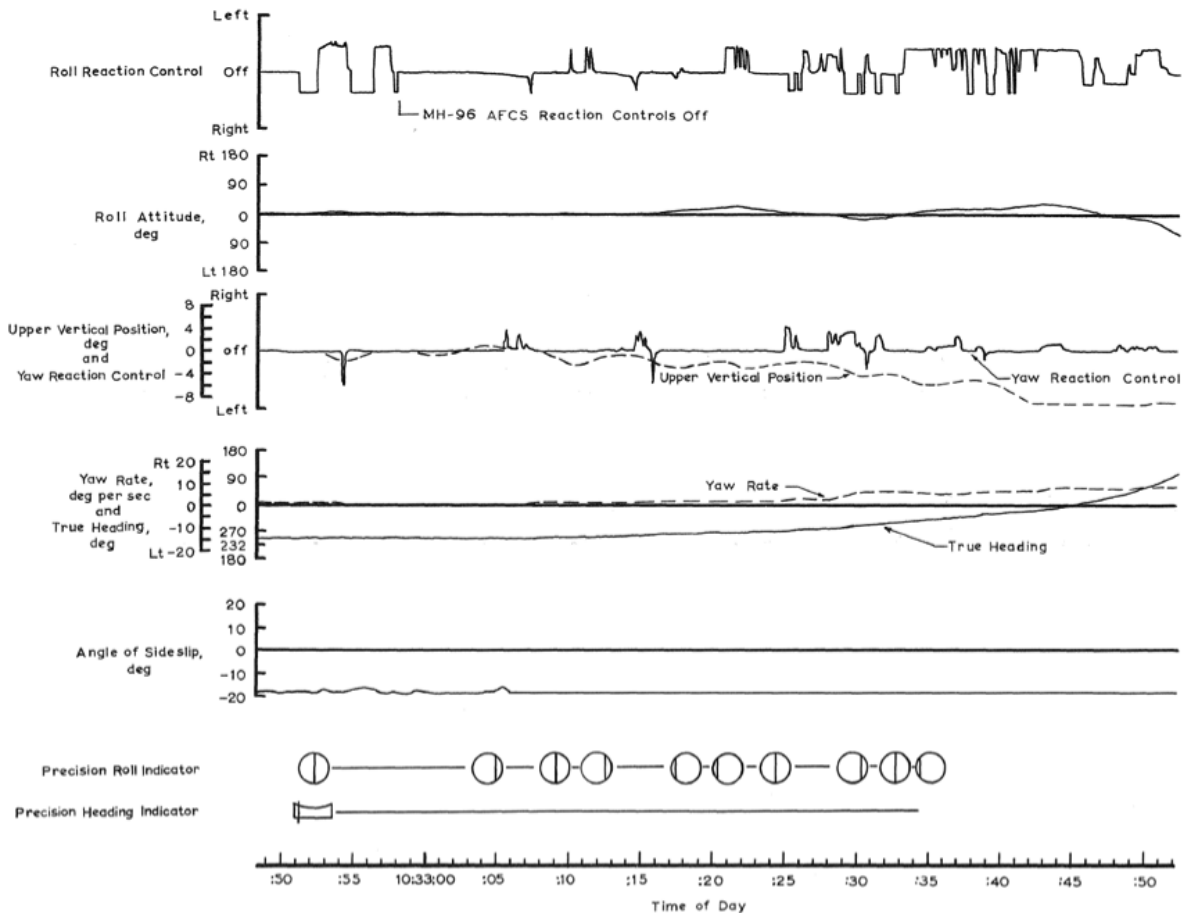
Figure 9.2-1. Time History of Precision Attitude Tracking Task at Peak Altitude [ref. 3]

The evidence suggests the pilot forgot he was in the PAI mode when he switched to the left-hand stick RCS control. However, at the moment he switched control, he was performing the precision attitude-tracking task (Figure 9.2-1) and he continued to try to complete that task after he switched hands. It is difficult to believe that the pilot would have forgotten that he was in the PAI mode while he was in the process of performing the very maneuver for which the PAI mode was specifically designed.

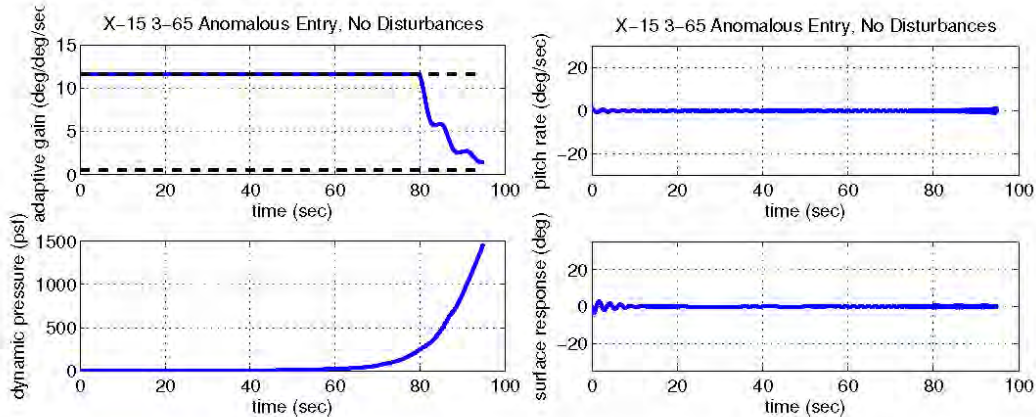
Figure A.14: MH-96 3-65 entry, no disturbances

The high dynamic pressure and dynamic pressure rate seen during the 3-65 anomalous reentry was within the design capability of the MH-96 adaptation gain dynamic range and adaptation rate so long as no exogenous disturbances caused saturation of the control surface actuators. This can be verified through simulation of the adaptation dynamics during the planned 3-65 entry (to approximately 800 psf) and the anomalous entry (exceeding 1500 psf). In both cases, since the system is operating in a ballistic mode prior to the entry, the adaptive gain is at maximum. Even when using the accident flight dynamic pressure

profile, the adaptive law is successful in establishing the desired servoactuator limit cycle and modulating the forward gain to the proper value (Figure A.14). This analysis result contradicts the author's early hypothesis that the adverse LCO was precipitated by a dynamic pressure rate-of-change exceeding the capability of the MH-96 gain changer.

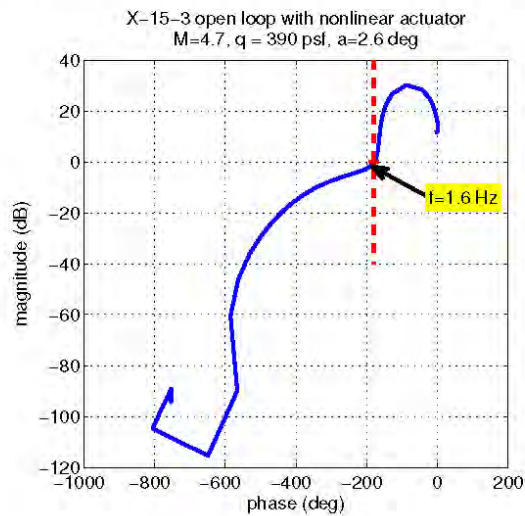
Figure A.21: X-15 servoactuator small-amplitude LCO prediction

Using the servoactuator DF in-the-loop at the stated forward gain condition, the small-amplitude LCO is accurately predicted by the numerical analysis. Since the forward gain in the DF analysis matches the converged gain, the system intercepts the critical point. The $-\pi$ phase line is shown for comparison. It should be noted that the short period mode, appearing at approximately 0.4 Hz, has relatively little equivalent phase margin at this condition at stable values of the forward gain.

It was noted before in the analysis of the high-frequency desired LCO that the short-period mode had very little phase margin when operating at the critical gain (Figure A.21). In the design of the MH-96, an implicit assumption was that the system phase shaping (via filters in the rate feedback path) provided for a linear phase margin that was approximately invariant with respect to the forward gain. Based on a comparison of the original system response with the flight configuration using the structural notch filter, it appears that the introduction of the notch filter substantially degraded the phasing of the short period mode due to the introduction of additional low-frequency lag (Figure A.23). Even under these conditions, the original design maintains more than 30 degrees of phase margin for the short-period mode.

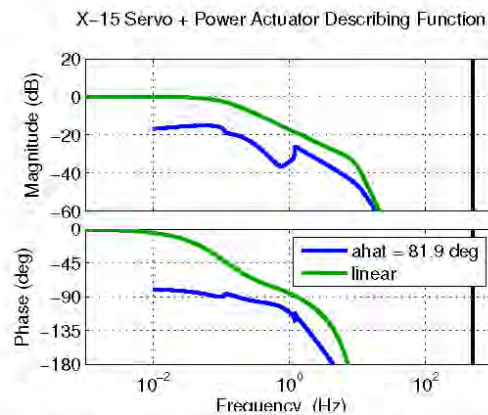
Figure A.22: X-15 servoactuator large-amplitude describing function

Based upon the time-domain analysis, it was observed that the large-amplitude LCO tended to be precipitated by large inputs causing actuator rate saturation coupled with an excitation of the short-period pitch mode. In order to determine the possible transition amplitude for the adverse LCO, the amplitude-frequency parameter space was searched for a DF such that the short-period mode would approach critical stability when at the 3-65 entry conditions (maximum forward gain, 390 psf). The transition amplitude for this condition consists of a large servo command of approximately 80 degrees peak equivalent, or a command-to-authority factor of about 6:1. Large servo commands exceeding the servocylinder limit of 1 inch (15 degrees equivalent) will cause saturation in the servo, the power actuator, or both. The effects of saturation on the actuator frequency response are shown in Figure A.22. Near the short-period frequency, the effective phase lag is increased by approximately 25 degrees.

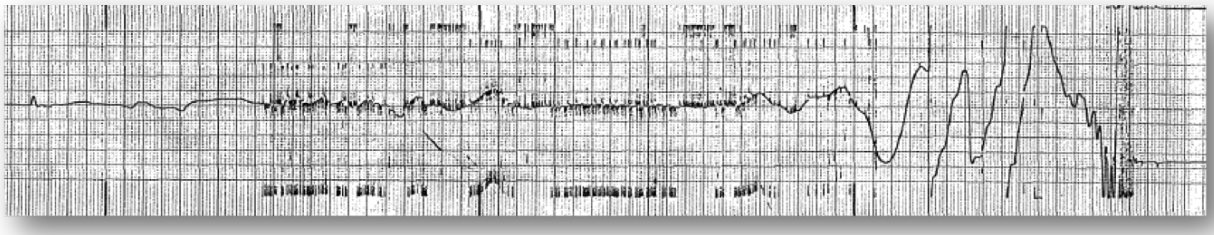
Figure B-1. Example of Original Strip Chart Recording

Flight data from X-15 Flight 3-65 appearing in this appendix were reconstructed from a photocopy of the original strip chart recordings (see Figure B-1) appearing in the 1968 AIB report [ref. 3]. As can be expected with data of poor quality, it is subject to some uncertainty and contains a number of filtering artifacts. It is, however, the best available representation of the aircraft states known to the authors.

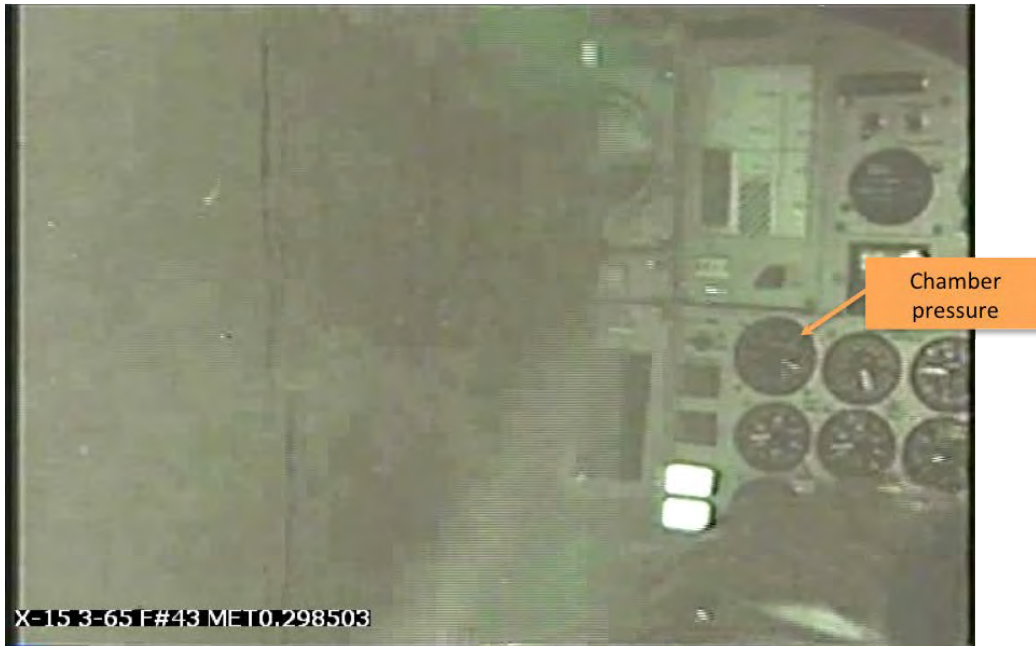
Figure B-8. Cockpit Film – Ignition Indicated by Increasing Chamber Pressure (MET = 0 seconds, 10:30:08 PST)

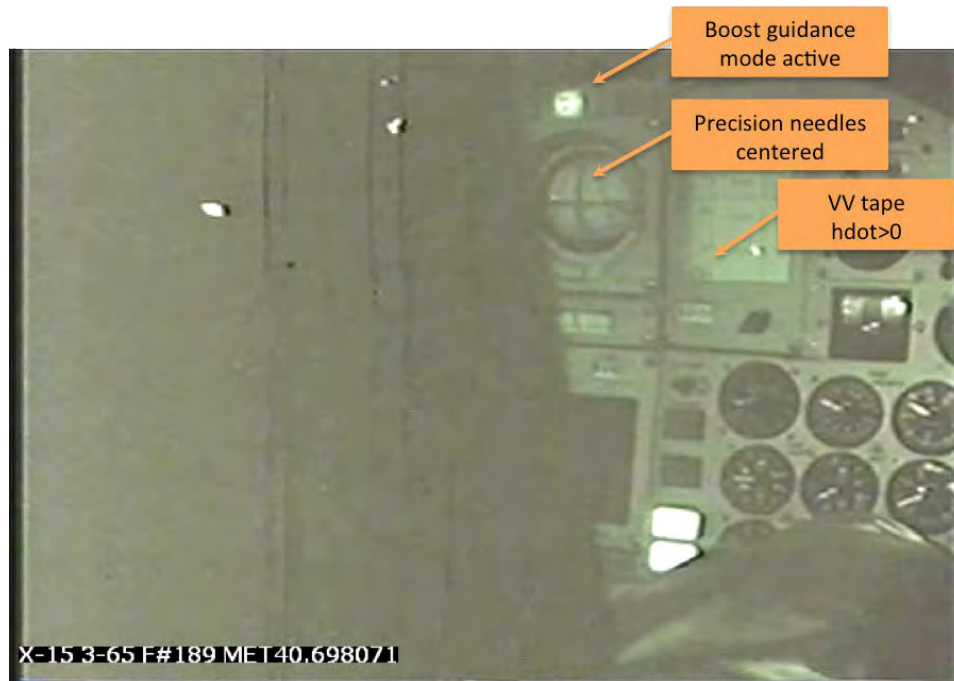
Figure B-9. Cockpit Film – Boost Phase (MET = 41 seconds, 10:30:49 PST)

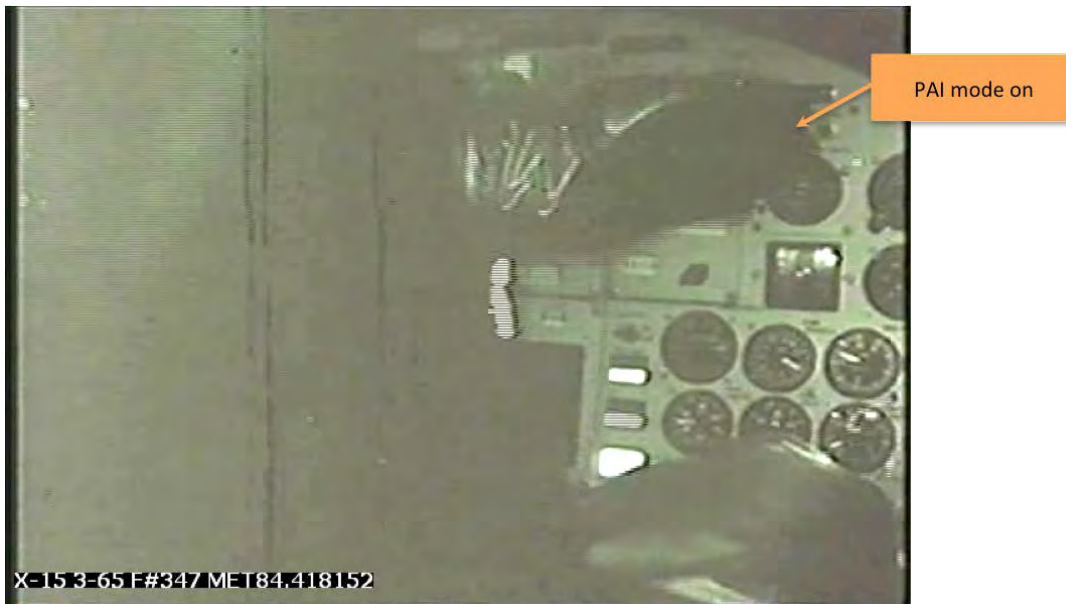
Figure B-11. Cockpit Film – Pilot Engages PAI (MET = 84 seconds, 10:31:32 PST)

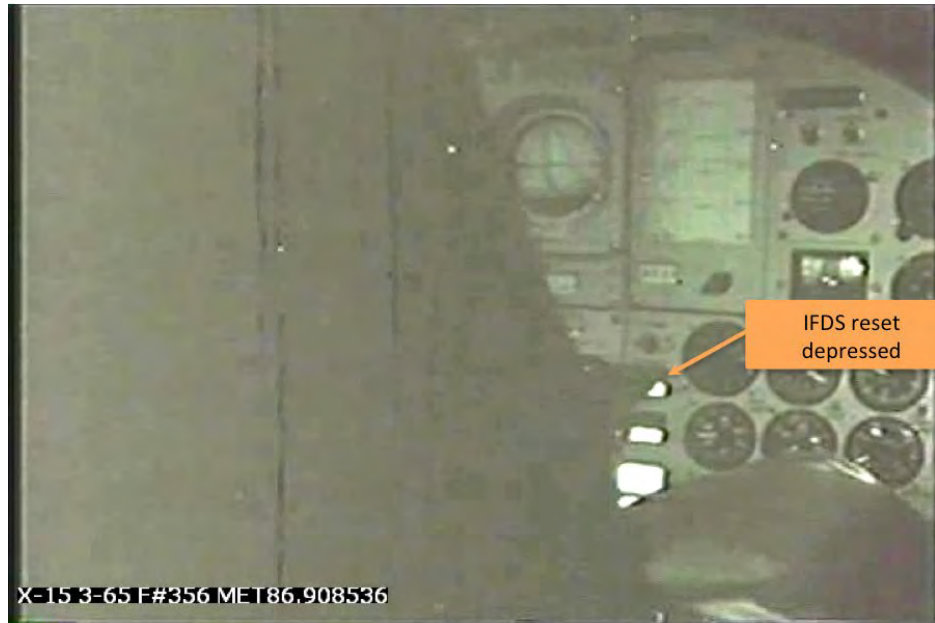
Figure B-12. Cockpit Film – Pilot Attempts IFDS Reset (MET = 87 seconds, 10:31:35 PST)

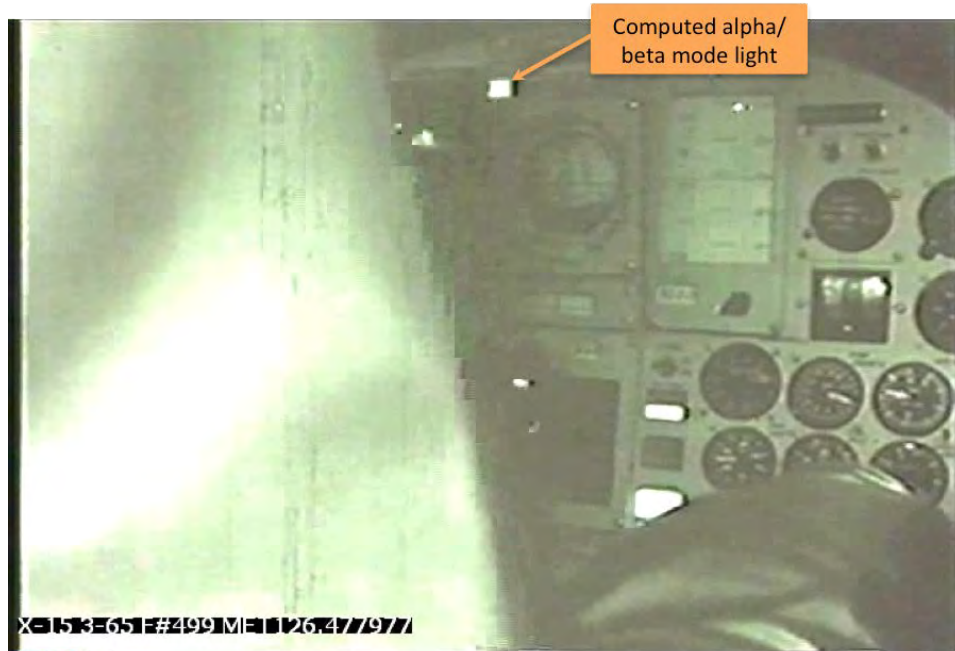
Figure B-13. Cockpit Film – Pilot Selects Computed IFDS Aerodynamic Angles <50 psf (MET = 126 seconds, 10:32:14 PST)

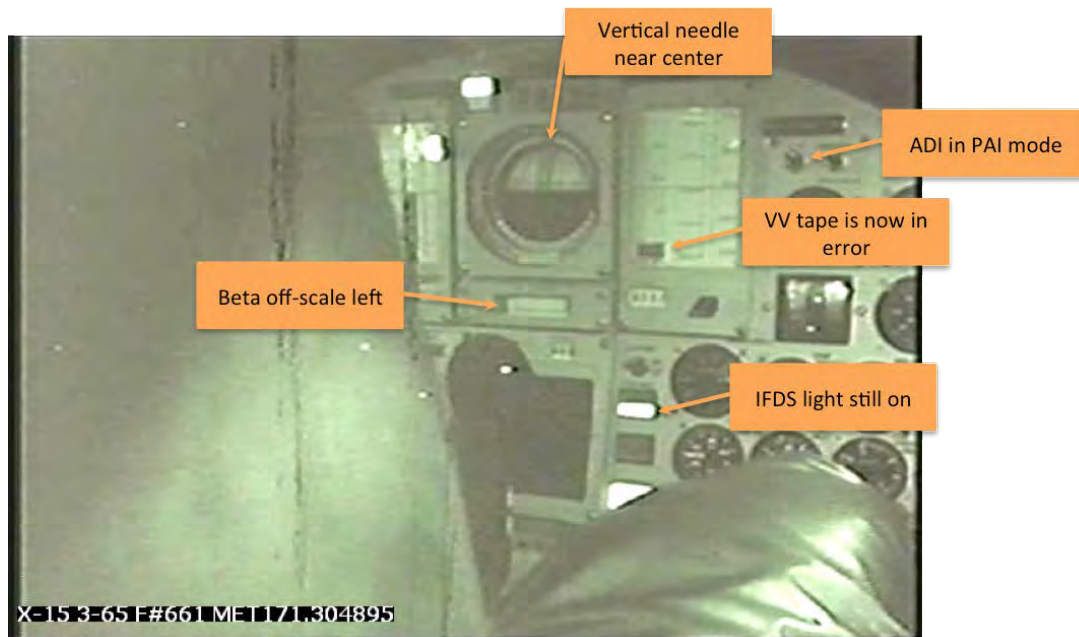
Figure B-15. Cockpit Film – Near Peak Altitude (MET = 171 seconds, 10:32:59 PST)

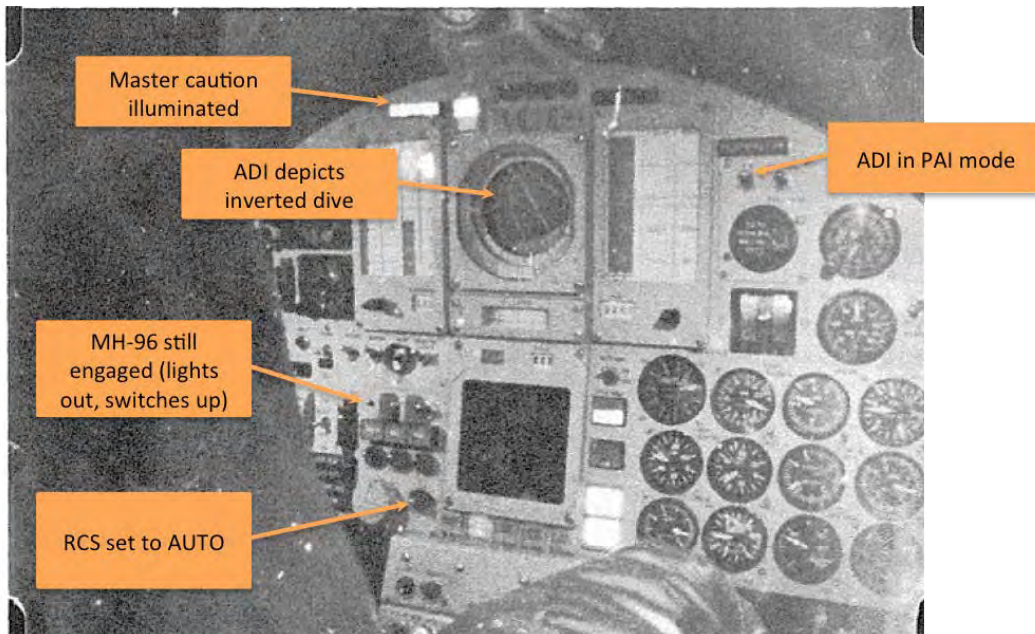
Figure B-17. Cockpit Film – Last Camera Frame (MET = 286 seconds, 10:34:54 PST)
