NASA/TM—2014–218414

The Human Factors of an Early Space Accident: Flight 3-65 of the X-15

Immanuel Barshi
NASA Ames Research Center

Irving C. Statler
NASA Ames Research Center

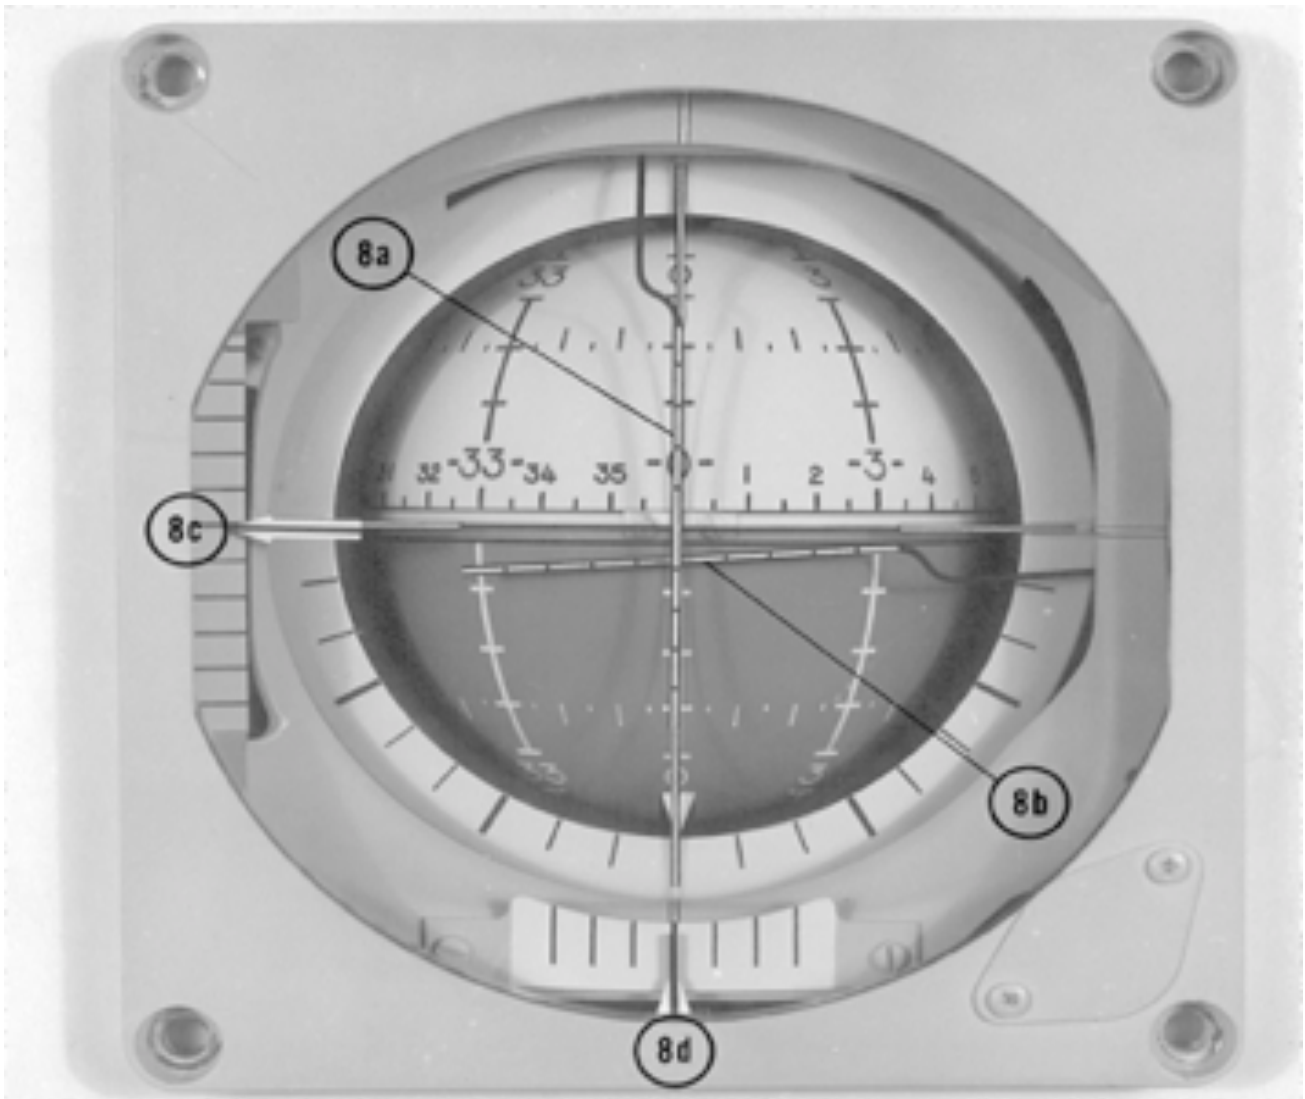
Figure 3b. The Attitude Director Indicator in the X-15-3 (Figure 3b in AIB report).

In the usual normal operation of all three configurations of the X-15, the pilot's Attitude Director Indicator (ADI) in the center of the control panel (Item 8 in Figure 3a) was a standard freely rotating sphere called the '8-ball' and its faceplate displayed a fixed reference aircraft symbol (Figure 3b). The sphere itself was bisected into white and black areas representing sky and earth, respectively. The ADI was a critical instrument because the typical X-15 ballistic flight profile prevented pilots from seeing Earth's horizon until re-entry and the degree of precision flying required by the mission demanded constant reference to flight instruments until landing. Moreover, the pilot was dependent on the ADI to perform the maneuvers required for the experiments with the X-15-3 with the required precision. Normally, the needles labeled 8a and 8b in Figure 3b indicated sideslip error from zero and angle of attack error from preset, respectively. Needle 8c displayed error from a ground preset of the desired climb attitude. Needle 8d indicated error from a ground-preset heading.

- Further, the mode indicator light on the display panel was innocuous. There were four attitude-indicator-deviation-needle function switches (switches 7a–7d in Figures 3a and 3b). Two of these were push-to-select switches related to normal ADI configurations and one was a push-to-select switch related to energy management that was not operational on Flight 3-65. Each of these switch faces illuminated with a small white light when that particular function was selected. The fourth was a toggle switch to select the PAI mode when it was in the up position. This toggle switch did not have an indicator light; the position of the switch was the only indication of whether the PAI mode was on or off. When one function was activated, the previously selected mode was automatically disengaged. This was an inadequate display of modes. The indication of the mode should be on the display itself, not on the mode activation switch. In the case of the X-15-3, the entire ADI should have been clearly marked for each of the modes in which that display was used.
